# WATER QUALITY MEMORANDUM

Utah Coal Regulatory Program

RE: 2009 Third Quarter Water Monitoring, West Ridge Resources, West Ridge Mine,  
Task ID #3395

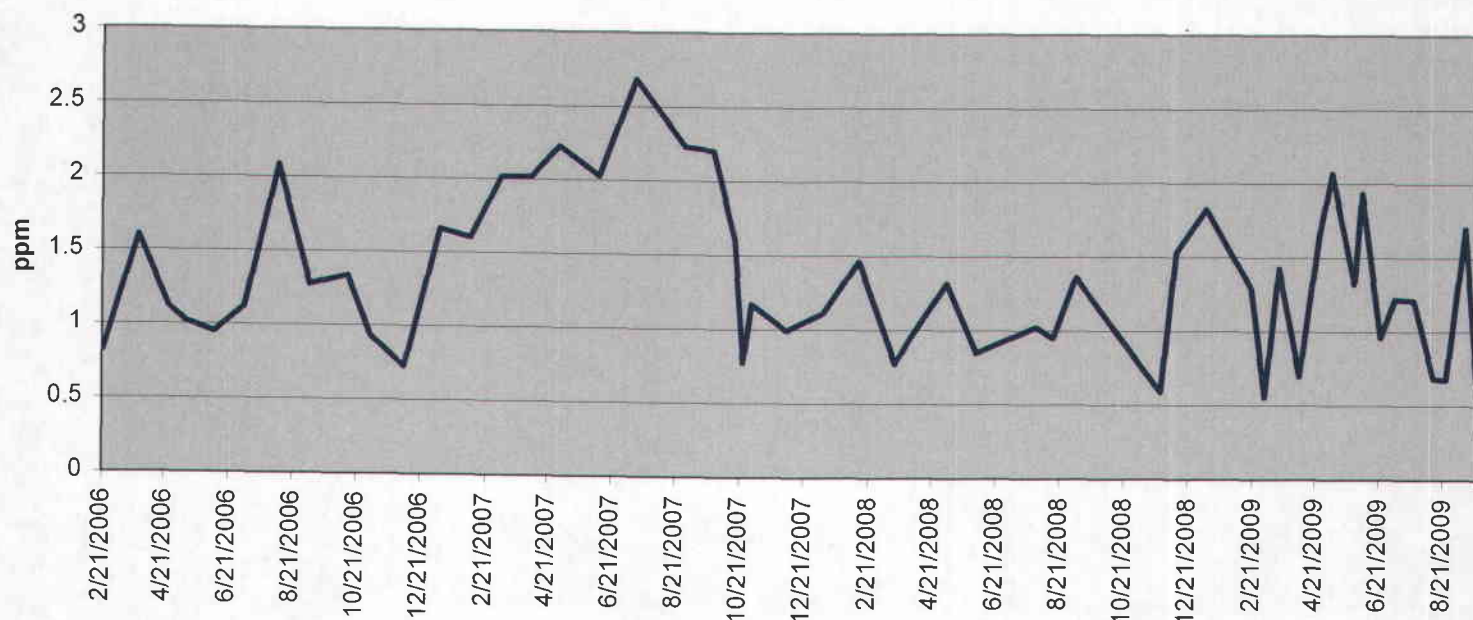
**UPDES Outfall DOO2: Total Iron (T-Fe) vs. Time**

T-Fe at outfall D002 has exhibited similar erratic trends (See Chart Below). T-Fe levels were particularly high during most of 2007 with a maximum reported value of 2.682 ppm. For 2008, T-Fe levels essentially stayed within the compliance level of 1.3 ppm as outlined in the UPDES Discharge Permit.

However, during the 1<sup>st</sup> quarter of 2009, the standard for T-Fe (1.3 ppm) was exceeded

three times out of six sampling events (1.423 ppm, 1.478 ppm and 1.824 ppm). Based on six sampling events for the 2<sup>nd</sup> quarter of 2009, reported T-Fe levels exceeded the 1.3 ppm standard four times (1.629 ppm, 2.07 ppm, 1.32 ppm and 1.934 ppm).

Outfall 002 was sampled 6 times during this quarter. Of the six samples, one was reported out of compliance with a concentration of 1.699 ppm.

The Permittee has modified the routing and treatment of the mine-water underground. A flocculent has been utilized on the mine-water prior to its discharge at Outfall 002. In addition, a series of catch basins were constructed within the C Canyon Drainage. In July of this quarter, the Permittee initiated clean-up efforts of the coal fines within the stream channel. The Permittee was successful in dislodging the material and removing it from the catch basins. Approximately 300 tons of material was removed from the drainage. As a result, Notice of Violation #10033 was terminated on August 26<sup>th</sup>, 2009. The permitting process will continue on the catch basins, as it was the general consensus of the regulatory agencies that the basins remain in place during active operations at the mine.

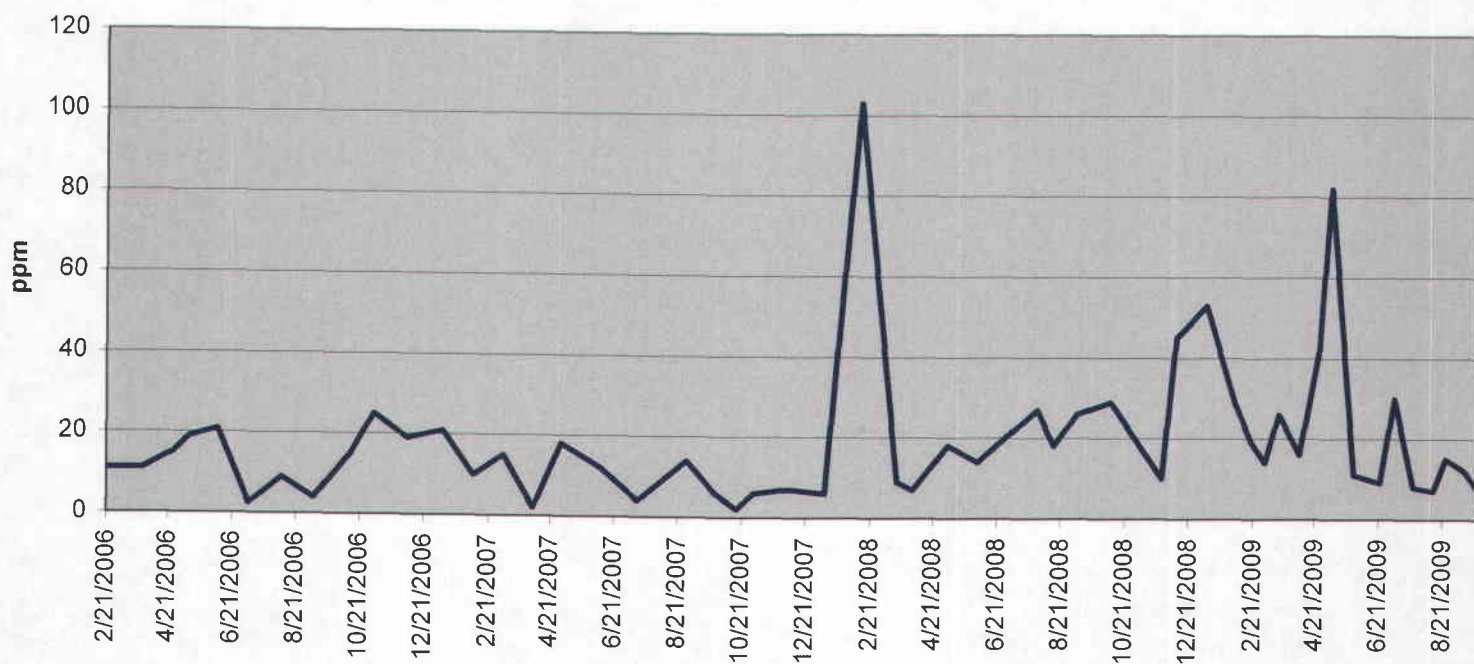
**UPDES Outfall D002: TSS vs. Time**

**Site D002-** UPDES Outfall 002 has exhibited fluctuating levels of TSS and T-Fe historically (See Charts below).

During the 1<sup>st</sup> quarter of 2008, a TSS value of 103 ppm was reported for D002, which exceeded the 70 ppm standard established in the Permittee's UPDES Discharge Permit (# UT0025640). However, for the next 3 consecutive quarters (2<sup>nd</sup>, 3<sup>rd</sup> and 4<sup>th</sup> quarters of 2008), the TSS levels were within the 70 ppm compliance level.

In the 1<sup>st</sup> quarter of 2009, the mine-water discharge at site D002 produced a TSS value outside of two standard deviations from the mean. However, that value (53 ppm) was within the 70-ppm compliance level. Out of 4 sampling events during the 2<sup>nd</sup> quarter of 2009, one TSS value was reported above the 70-ppm compliance levels (82 ppm). Outfall 002 was sampled 6 times during this quarter. All six samples reported TSS levels well below the 70 ppm compliance level.

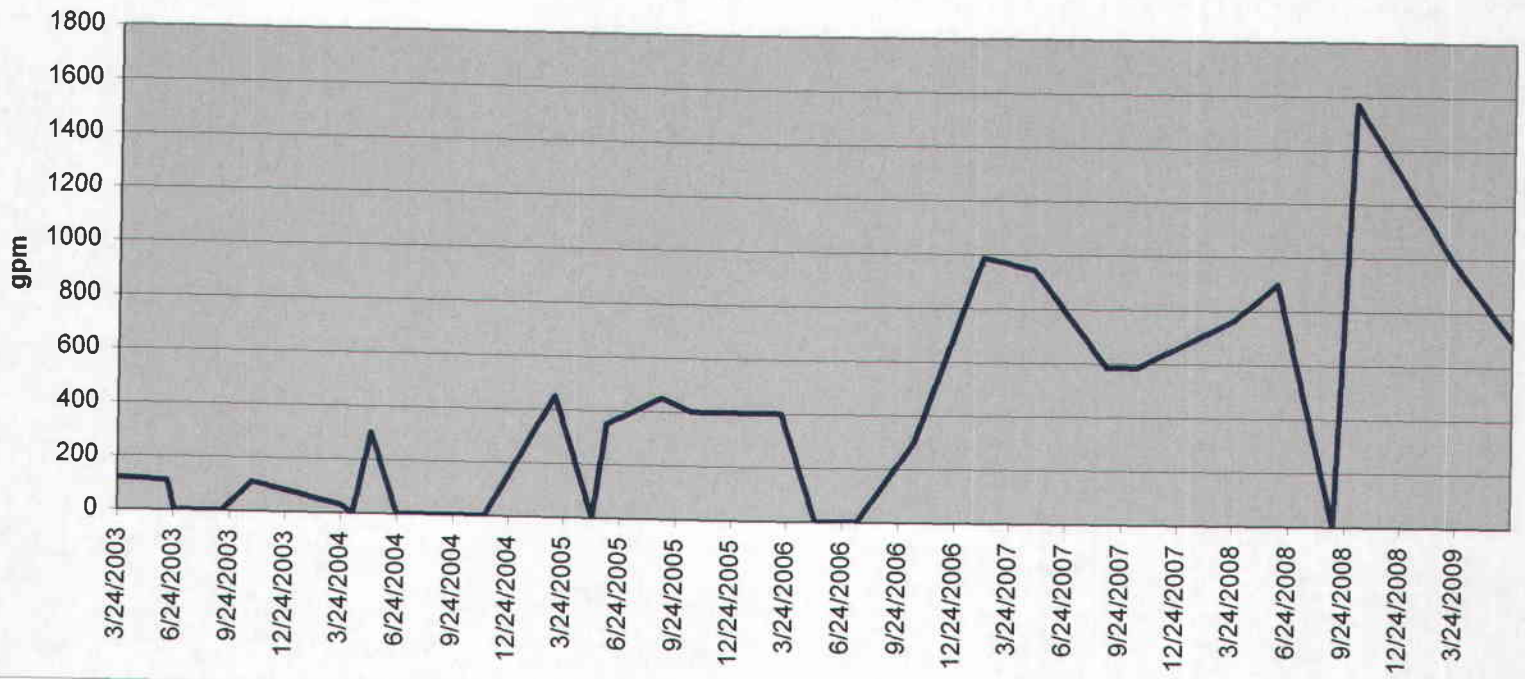
**ST-5: Flow Values**

**ST-5-** Flow values had been steadily rising at surface water monitoring site ST-5 (See Chart Below). Four of the last six quarters of monitoring have produced flow values outside of two standard deviations from the mean. Based upon field inspections and discussions with the Permittee, it's apparent that the majority (if not all) of the flow within this ephemeral drainage is coming from the mine-water discharge. The 2<sup>nd</sup> quarter of 2009 and now this quarter have reported lower flow values. Based upon discussions with the Permittee, the encountered mine-water underground has been re-routed. In order to facilitate the settling of T-Fe and TSS from the mine-water prior to discharge, the Permittee has routed the water into a mined out section of gob. The re-routing will effectively lengthen the flow path the mine-water must travel prior to discharging. As a result, flow values have been reduced.

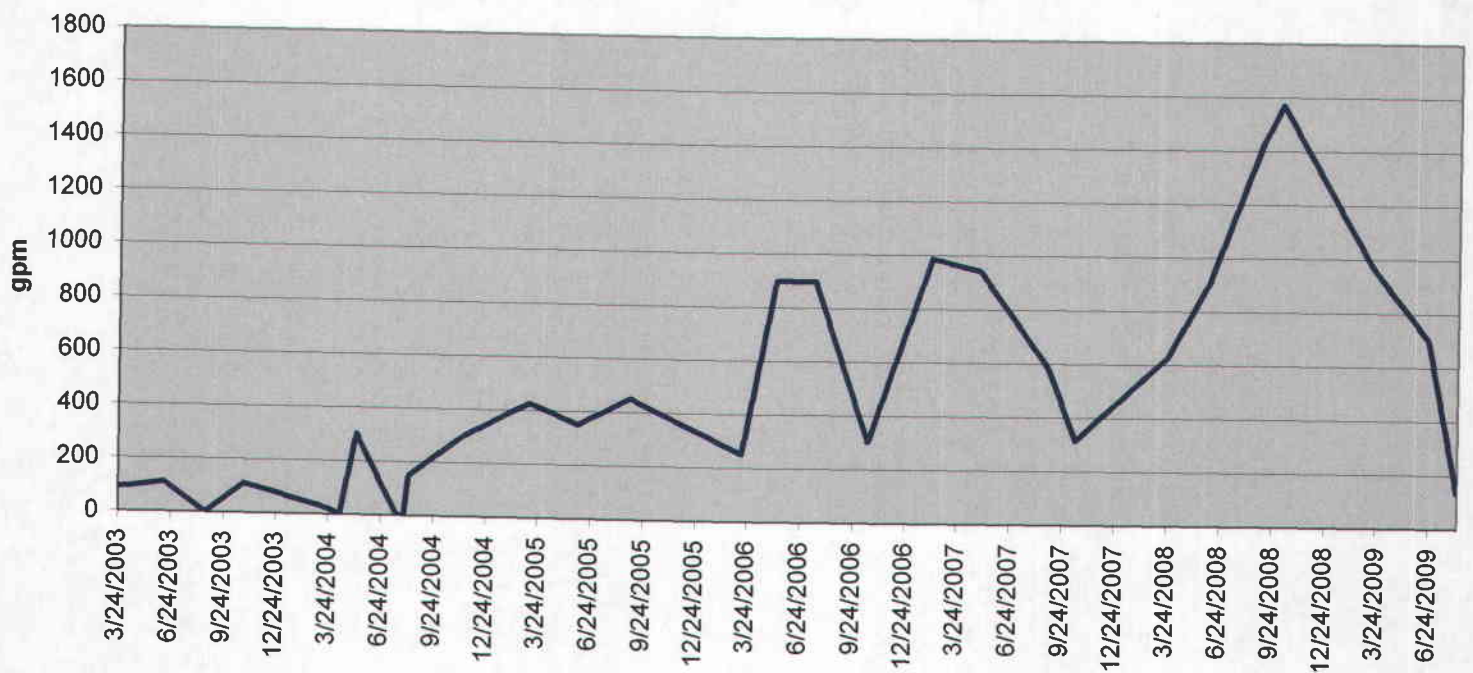
**ST-6: Flow Values**

**ST-6-** As with site ST-5, the majority (if not all) of the flow within this drainage comes from the mine-water discharge. Two of the last three quarters had reported increased flow values outside of two standard deviations from the data set.

The reported flow value for this quarter was significantly lower at 134.64 gpm. This value represents the lowest flow value at site ST-6 since August 11<sup>th</sup>, 2004. As with Site ST-5 (See Discussion Above), the re-routing of mine-water has produced a reduction in flow measured at site ST-6 (directly below UPDES outfall D002).

**ST-5 and ST-6-** The flow's at these two sites are producing very similar trends. These trends provide further evidence that the flow within these two drainages is primarily from mine-water discharge. (See Charts Below).

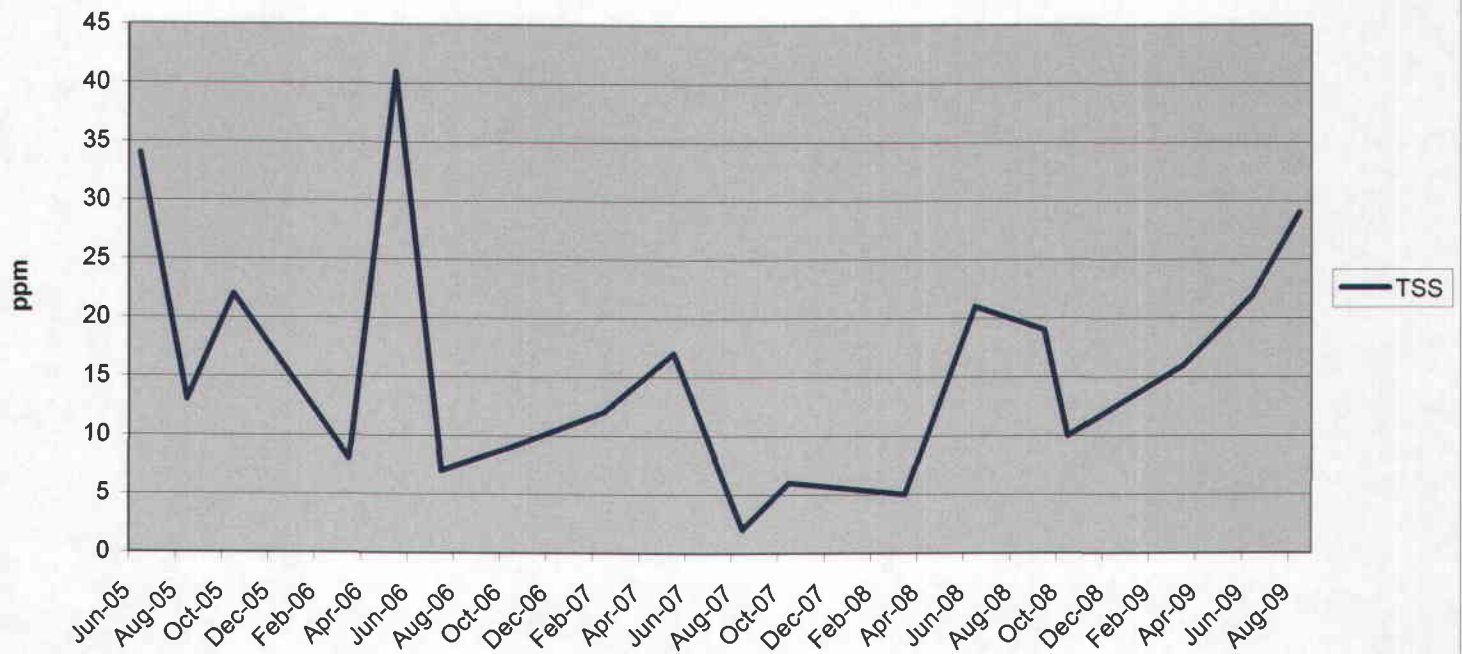
**ST-5: TSS vs. Time**

The reported TSS value for site ST-5 this quarter is 29 ppm. TSS concentrations (like T-Fe) are producing a significant upward trend. However, the TSS values are well within the 70 ppm water quality standard established in the UPDES discharge permit.

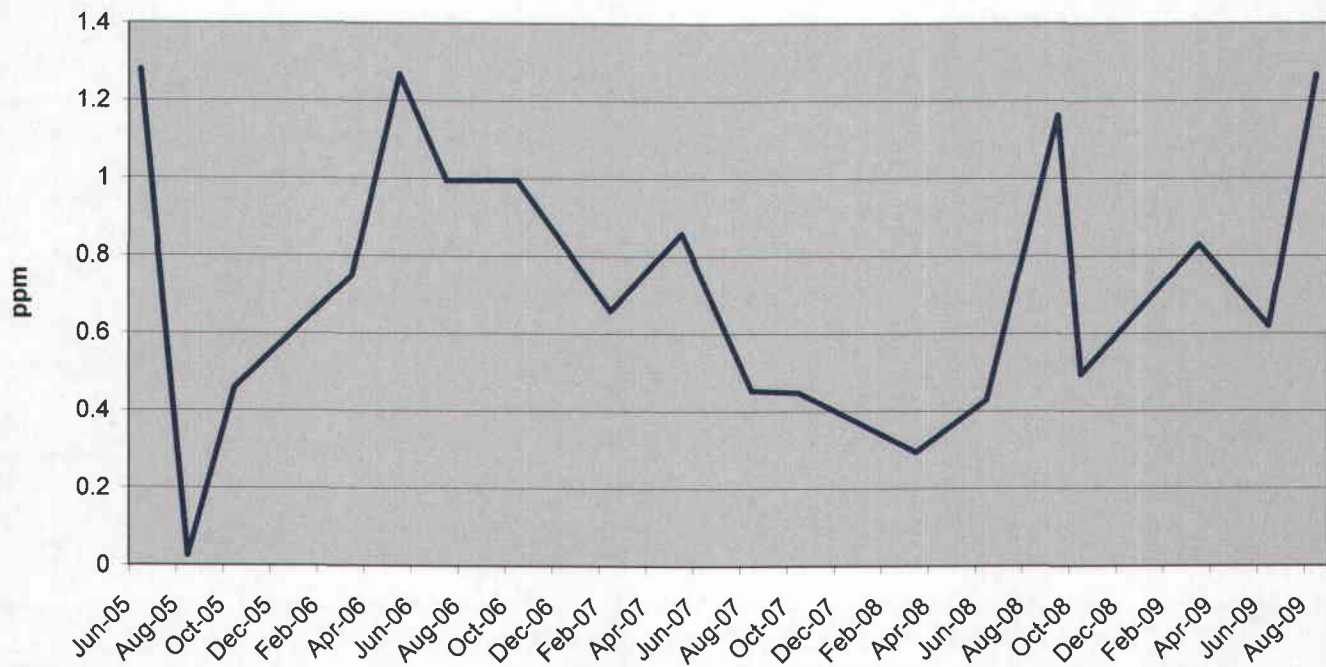
**ST-5: T-Fe vs. Time**

The reported T-Fe value for site ST-5 this quarter is 1.268 ppm. Though this value is within two standard deviations of the mean, it is very close to the UPDES discharge permit limit of 1.3 ppm for T-Fe. It appears that the elevated T-Fe concentrations in the mine-water discharge are not isolated to the outlet of UPDES outfall D002.

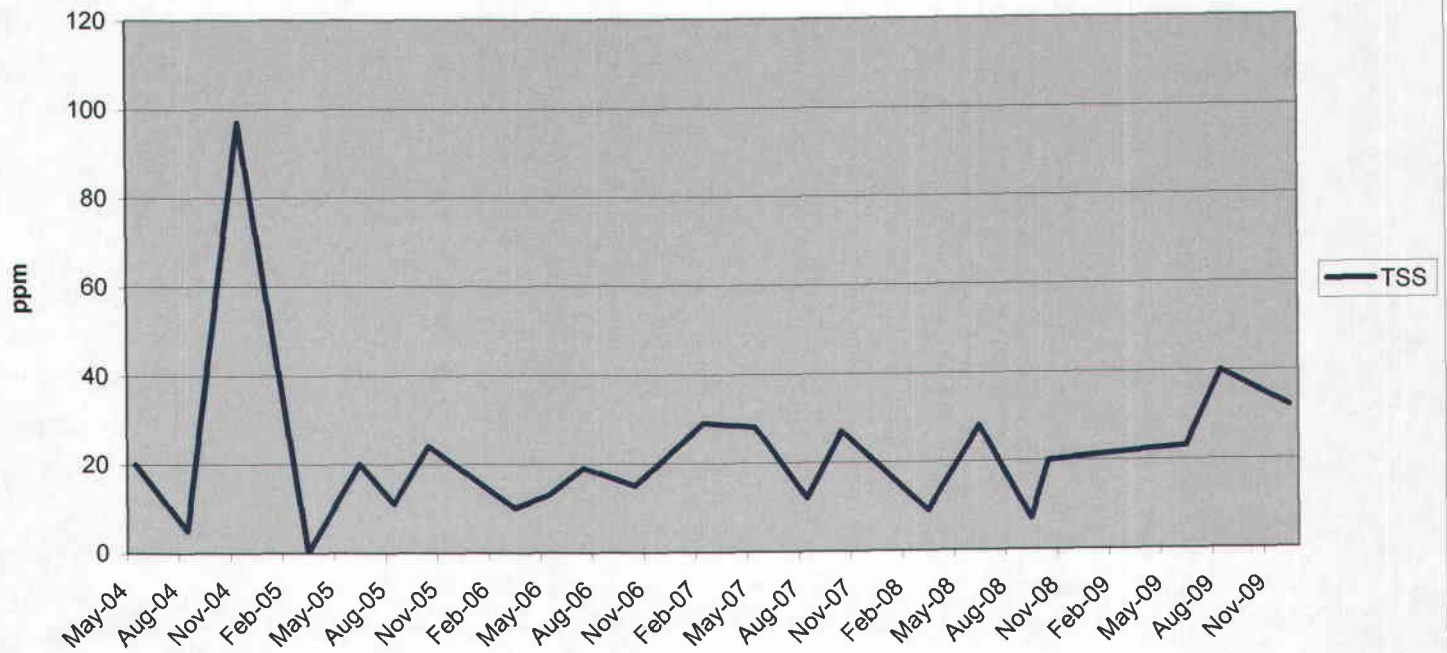
**ST-6: TSS vs. Time**

TSS levels have also steadily increased. This quarter reported a TSS value of 40 ppm, which is the fifth consecutive quarter of increasing TSS concentrations at ST-6. Though well below the 70 ppm water quality standard established in the UPDES discharge permit, it does appear that the increased TSS levels in the mine-water discharge (UPDES Discharge Outfall D002) are not isolated, but rather producing measurable increases downstream. Continued monitoring will be conducted.

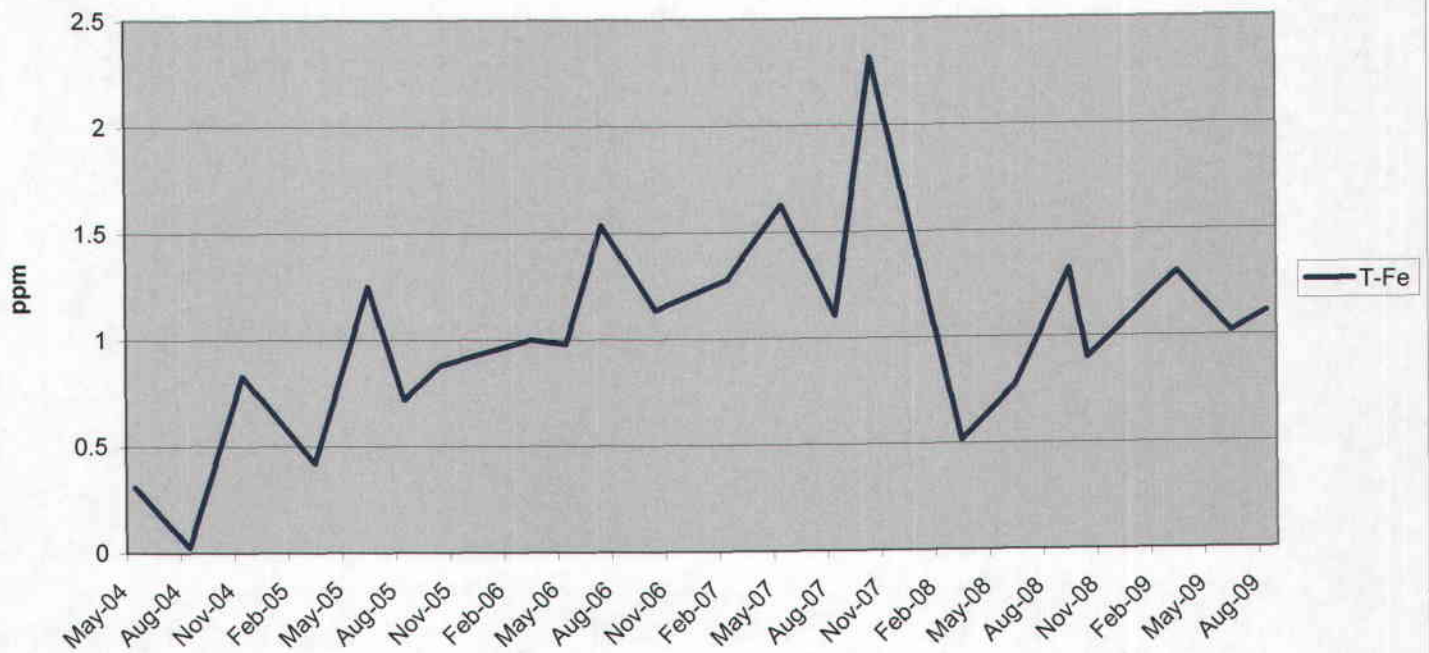
**ST-6: T-Fe vs. Time**

T-Fe levels have increased steadily at site ST-6 since approximately the 2<sup>nd</sup> quarter of 2008. The reported T-Fe concentration this quarter was 1.112 ppm. This value is within two standard deviations of the mean and within the 1.3 ppm water quality standard. However, it does represent the fourth out of the last five consecutive quarters with reported T-Fe values above 1.0 ppm.

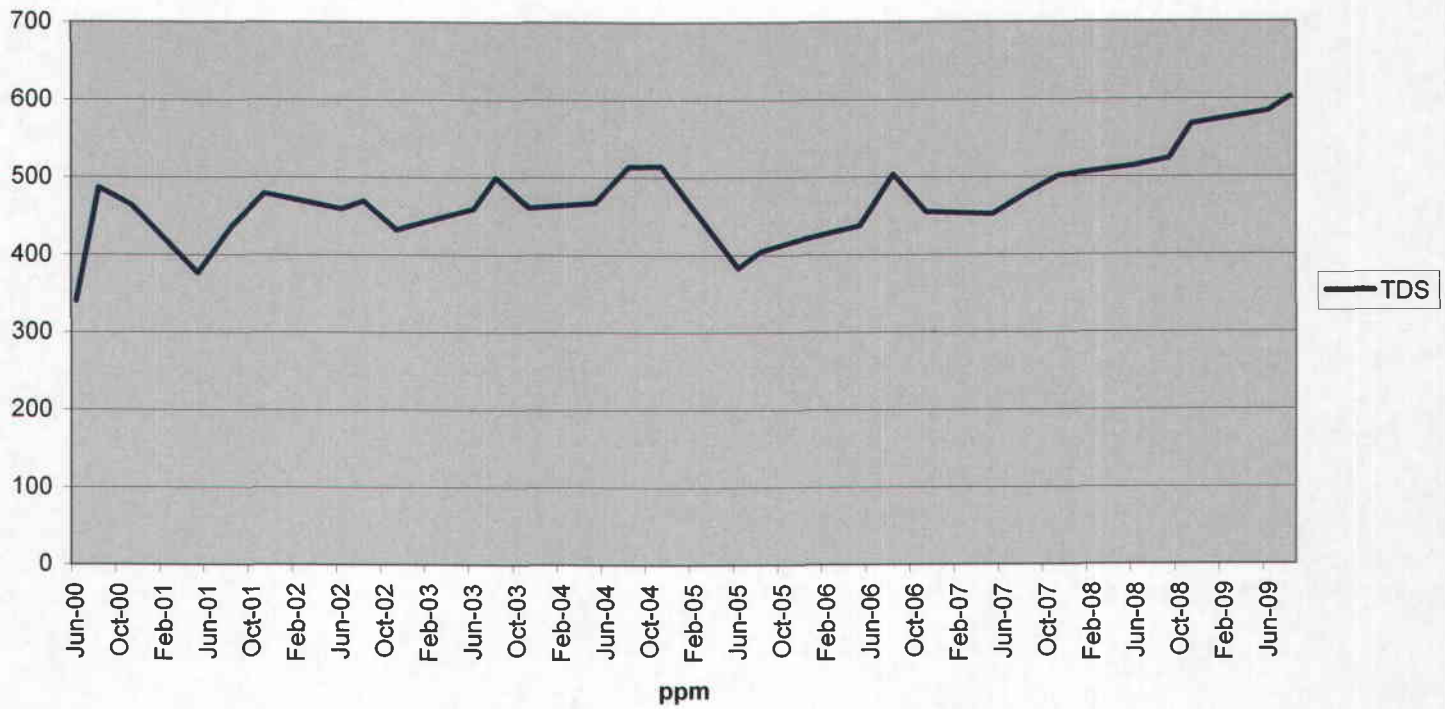
**Spring SP-12: TDS vs. Time**

**SP-12-** Sampling was not possible the previous quarter (1<sup>st</sup> quarter 2009) due to accessibility issues due to snow/mud. The second quarter's sampling from 2009 reported several parameters outside of two standard deviations: D-Ca, D-Na, SO<sub>4</sub>, L-Sp. Cond, TDS, Bcrb and Total Cations.

D-Na, L-Sp. Cond and TDS were again reported outside of two standard deviations. The increase in TDS is producing increases in its components. Based upon the data set, TDS has been steadily trending upward since monitoring began in 2000.

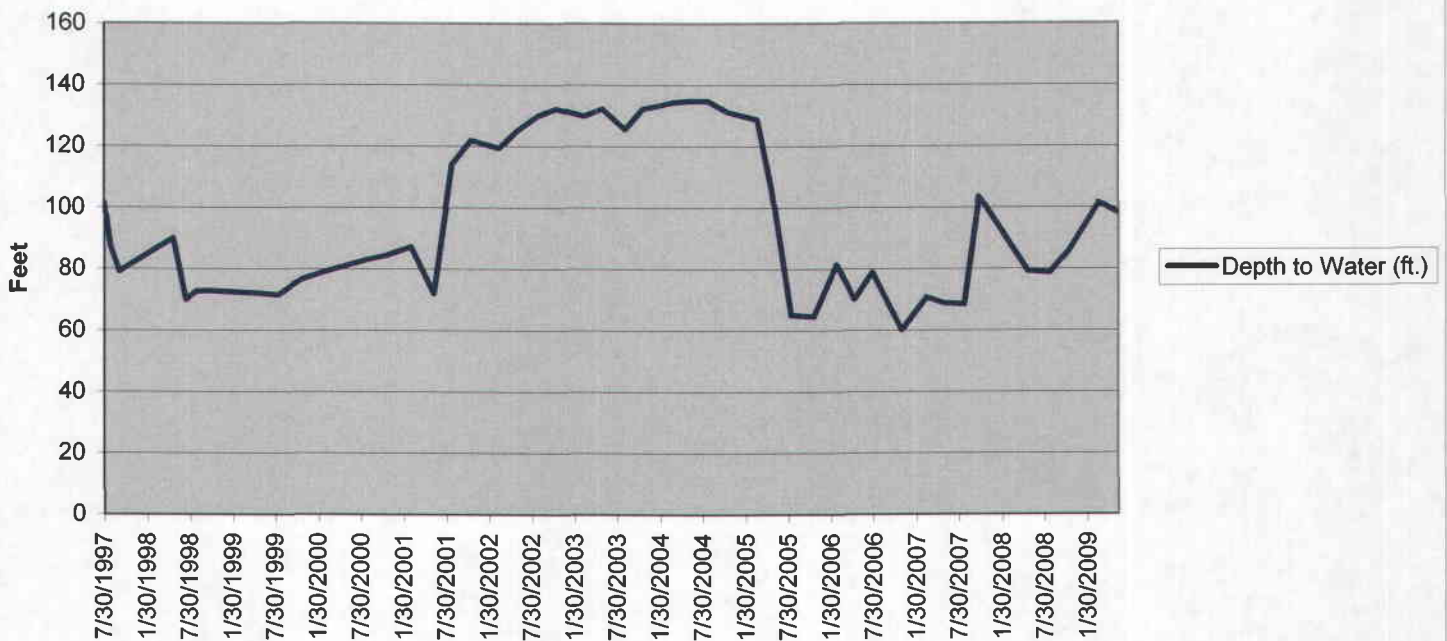
**Well DH 86-2**

**Monitoring Well DH 86-2** reported three values outside two standard deviations during the 2<sup>nd</sup> quarter of 2009: D-Ca, Cl and Total Cations. Several parameters were reported outside of two deviations for this quarter: D-K, Cl, T-Cats and T-Anions.

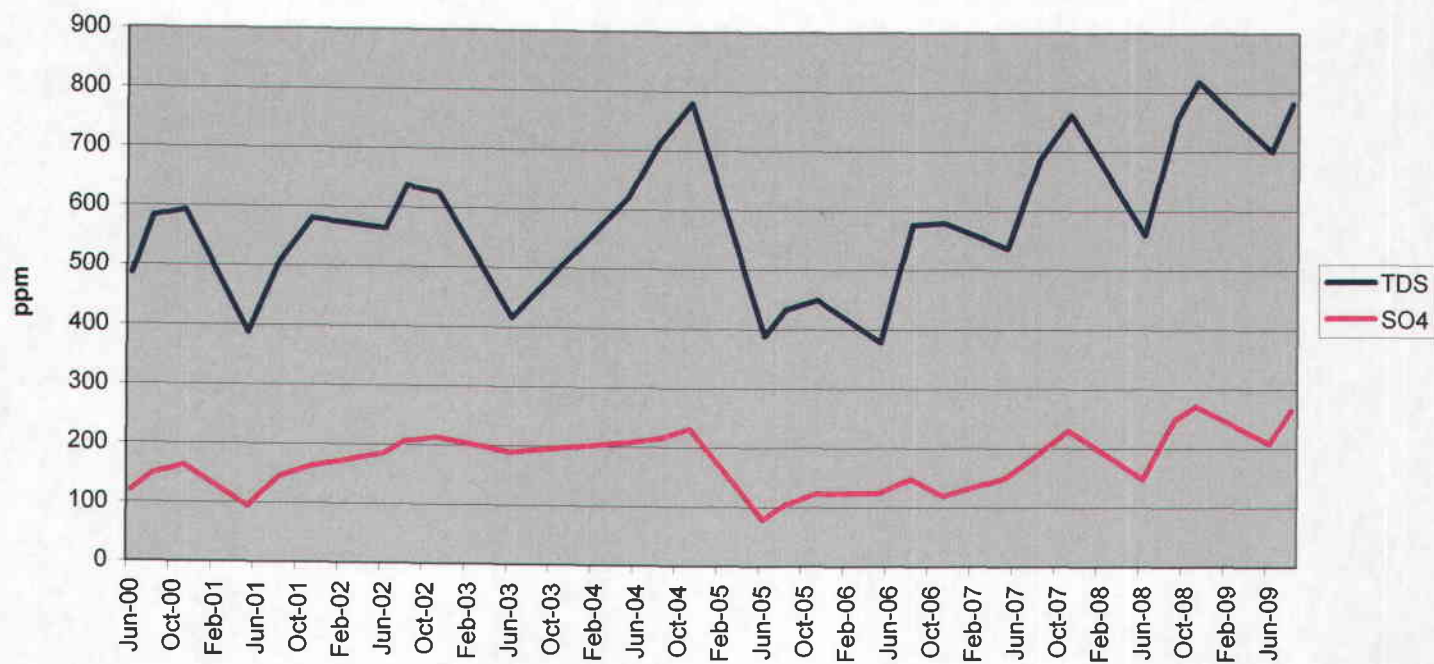
Spring SP-13: TDS, SO4 vs. Time

**SP-13-** Two parameters were reported outside two standard deviations from the data set during the 4<sup>th</sup> quarter of 2008 (D-Mg and T-Hdns). Due to weather conditions, the site was inaccessible during the 1<sup>st</sup> quarter of 2009. The second quarter's sampling from 2009 reported a value for D-Na that was out by 2.18 standard deviations.

Water temperature and D-Na were reported outside of two standard deviations for this quarter. As with SP-13, it appears that as TDS has been steadily increasing, so have associated components of dissolved constituents. (See Chart Below).
